Seapath, Inc. Update Reserve Study 2018 Revised

August 31, 2018

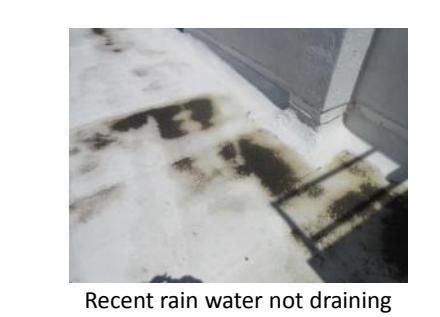
sufficiently.

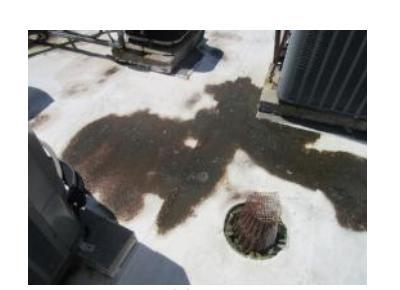
Buildup of fine sediment indicates insufficient slope to drains.

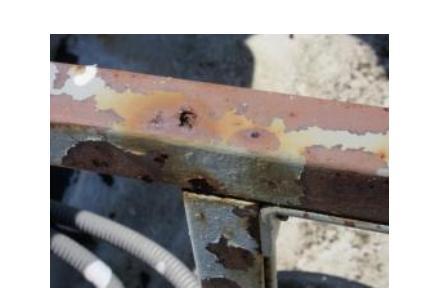
Unistrut system severely decaying.

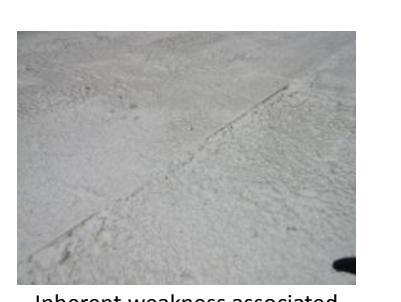
Inherent weakness associated with raised ridges.

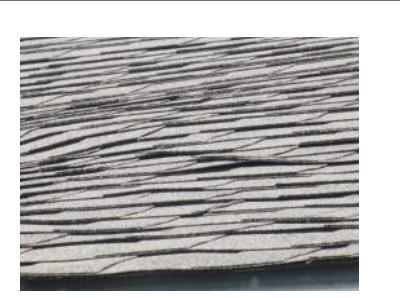
Some wind damage to roof shingles found.

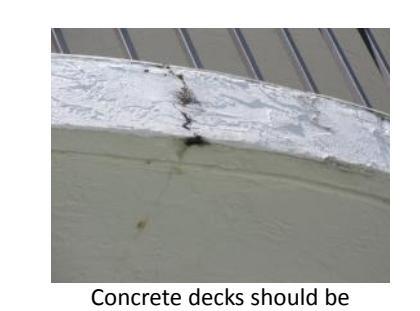
evaluated by structural engineer to determine integrity.

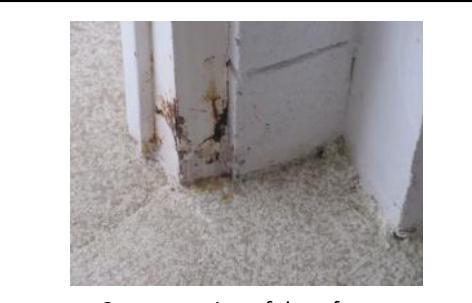
Severe rusting of door frames and hardware seen throughout.

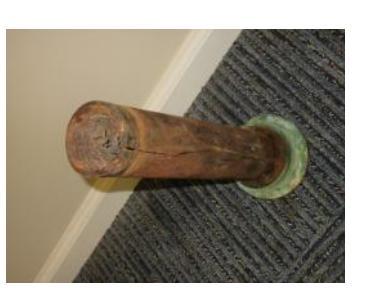
Cracking of cast iron waste pipe has been occurring sporadically.

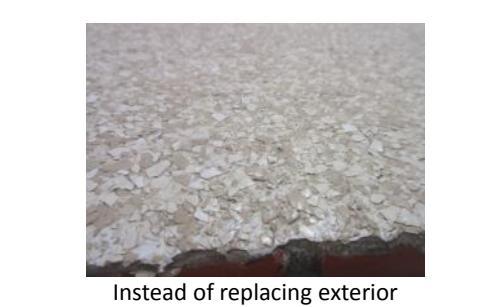
Instead of replacing exterior ceramic tile, flaked epoxy finish is being applied over top.

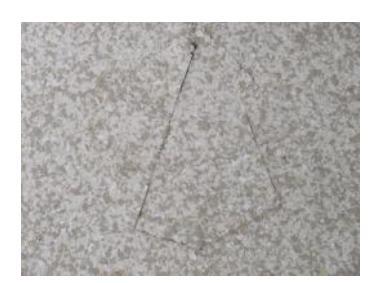
Although cheaper, more maintenance will be required.

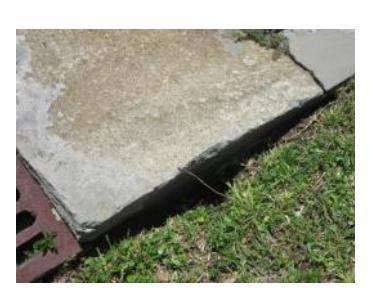
Stormwater eroding backside of stormbox.

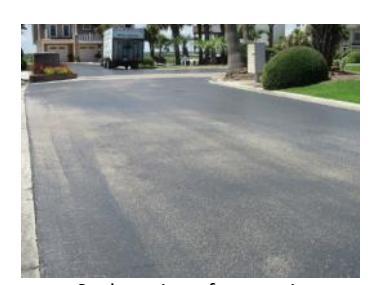
Seal coating of streets is minimally effective due to higher speeds eroding the surfaces.

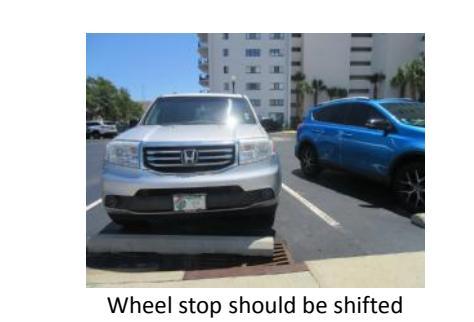
off storm drain.

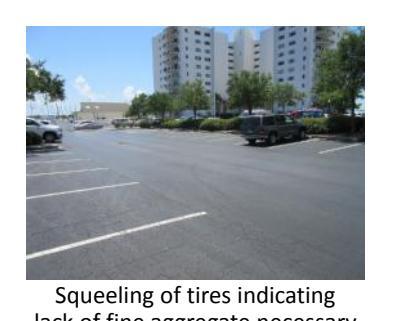
Squeeling of tires indicating lack of fine aggregate necessary for friction.

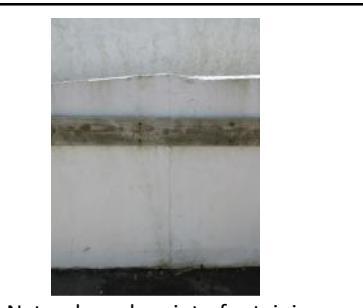
Natural weak point of retaining wall.

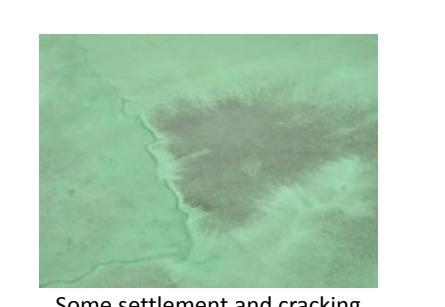
Some settlement and cracking of court.
